## How Gender and Family Friendly are Public Restrooms at the University of Illinois at Urbana-Champaign Campus?

An Evaluation of Eleven Major Campus Buildings Based on the Gender Equity Design Checklist.

A Report by the Provost's Gender Equity Council  
University of Illinois at Urbana-Champaign  
Co Chairs: Kathryn Anthony & Gale Summerfield  
Staff: Anita Kaiser & Kelly Sullivan

Date: May 9th, 2011

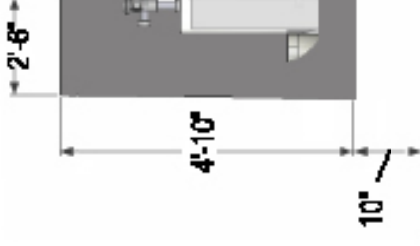
SECTION THROUGH INCREASED PRIVACY URINAL

- No partitions between men's urinals can be uncomfortable for some men.
- Adequate space should be provided between urinals. Most men despise trough urinals.
- Partitions are present, but not enough spacing in between urinal stalls.
- Men with shy bladder syndrome and paurens suffer when stalls are too close together.
- + Maximum spacing between urinals and stalls allow for larger men and/or men with bulky outerwear to be accommodated and offer more privacy.

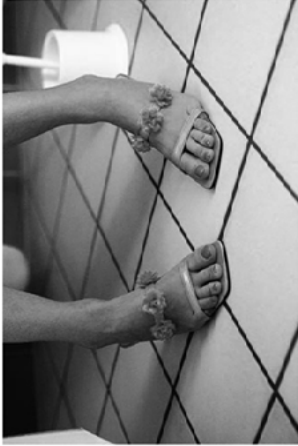
**BAD**

- Toilet partition distance from ground is too high allowing people to see under stall. Feet and shoes can be identified.

- Women with shy bladder syndrome and pauresis are uncomfortable under these conditions.

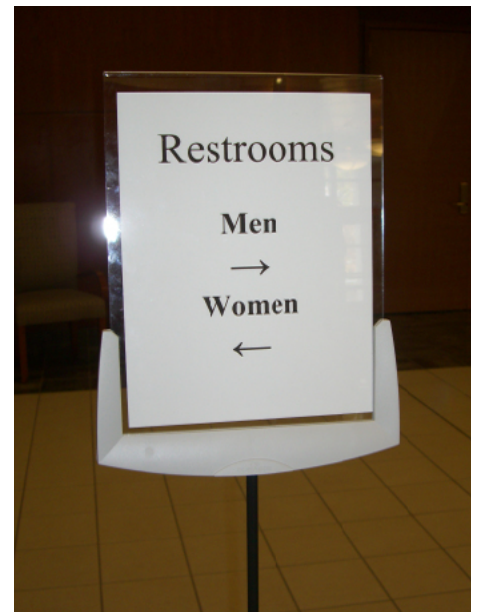
Figure 1: Restroom Signage on the first floor. Not Permanent

- Men's room is located at the west end of the building
- Women's room is located at the east end of the building
  - Restroom Signage on the first floor is not permanent and could easily be moved which could lead to confusion for visitors. (Fig. 1)

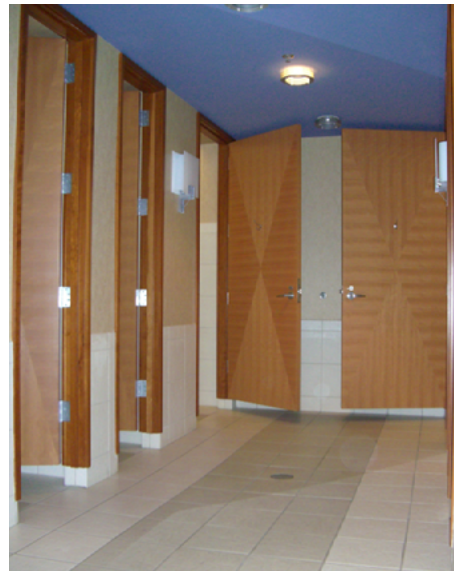
Figure 2: Best stalls in all of the 11 public buildings in the study. Total enclosure with door locks. Women's Restroom at the east end of the building on the Main floor.

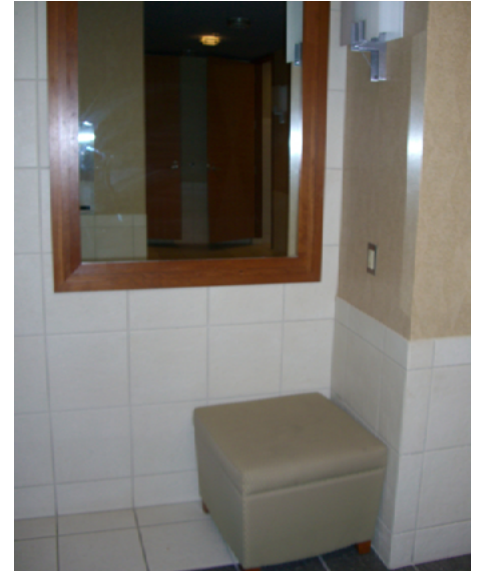
Figure 3: This space could potentially be outfitted with a changing station.

- Lactation Space (Bad)  
Lactation space is non-existent and thus does not meet the legal requirements for reasonable accommodations for nursing mothers. There is a small seat where a woman could sit but no privacy.
- + Partitions (Best)  
Total enclosure of stalls with door locks provides maximum visual and auditory privacy. Distance between toilet partitions is wide enough to accommodate larger women and bulky outerwear. (Figure 2)
- Changing Station (Bad)  
No changing station provided. (Fig. 3 & 4)

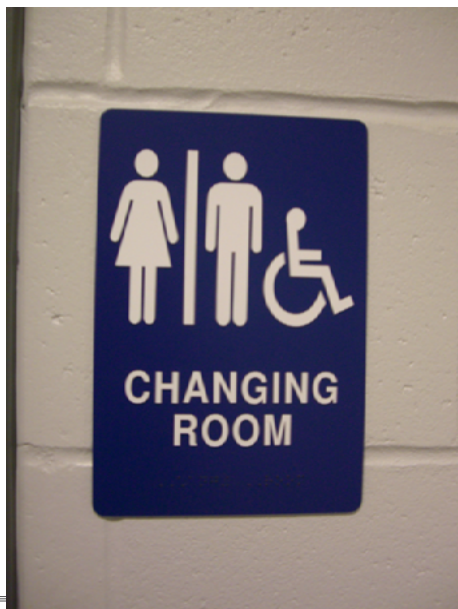
Figure 3: Signage for Gender Neutral Locker Room.

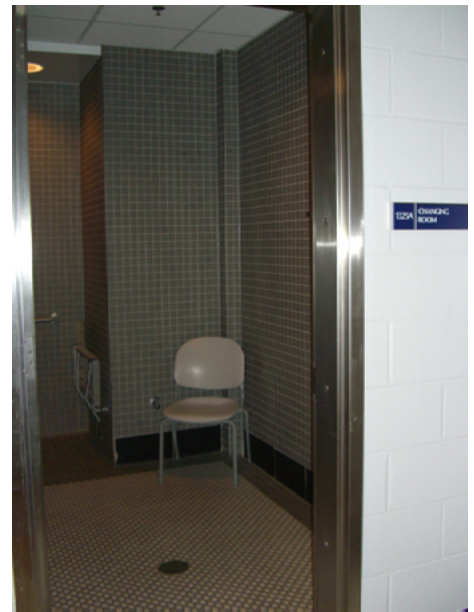
Figure 4: Changing Room off the main locker room area. Includes a shower and a baby changing station.

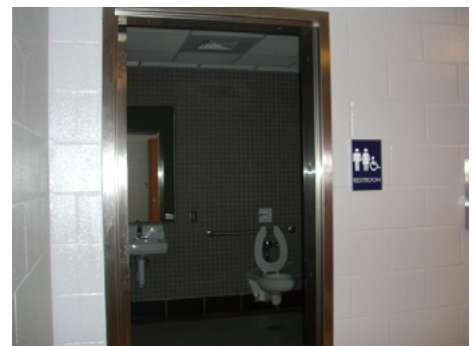
Figure 5: Unisex Bathroom located inside Gender Neutral Locker Room on concourse level near pools.

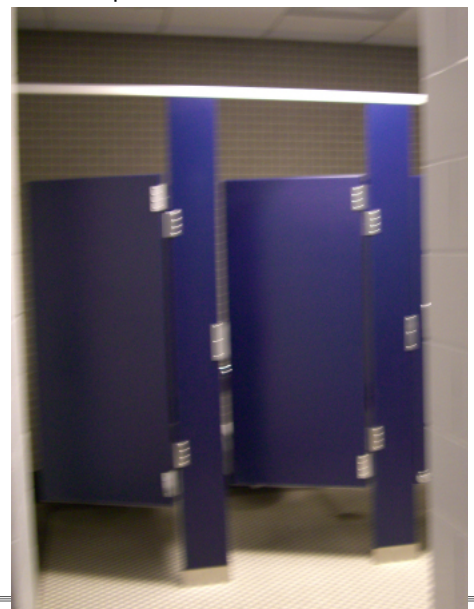
Figure 6: Bathroom stalls in the Women's Restroom on entrance level.

- Lactation Space (Bad)  
 No Lactation Space provided
- Partitions (Bad)  
 Toilet partition distance from the ground is too high allowing people to see under the stall. Feet and shoes can be identified. (Fig. 6)
- Changing Station (Bad)  
 No changing station provided

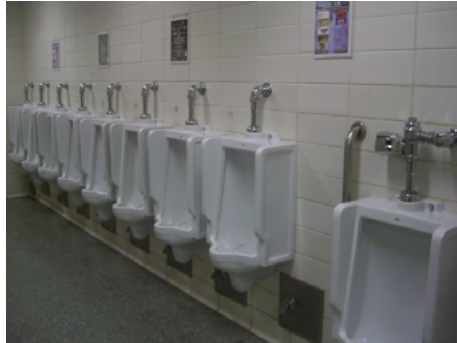
Figure 2

- + Appropriate signage (Fig. 1)
- Partitions (Bad)
  - No Partitions between men's urinals (Fig. 2)
  - Feet and shoes can be identified.
  - Spacing of stalls seems to be tight. (Fig. 3)
- Changing Station (Bad)
  - Baby-changing station is present adjacent to urinals but is not near sinks or paper towel dispensers. (Fig. 4)

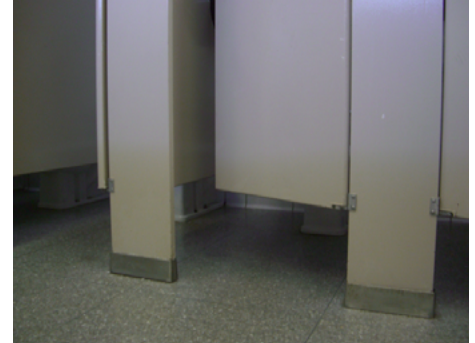
Figure 6

- + Appropriate signage (Fig. 5)
- Lactation Space (Bad)
  - Lactation space is non-existent and thus does not meet the legal requirements for reasonable accommodations for nursing mothers.
- Partitions (Bad)
  - Toilet partition distance from the ground is too high allowing people to see under the stall (Figure 6). Feet and shoes can be identified. Spacing of stalls seems to be tight. (Fig. 6 & 7)
- Changing Station (Better)
  - Baby-changing station is located near a sink and paper towels. (Fig. 8)

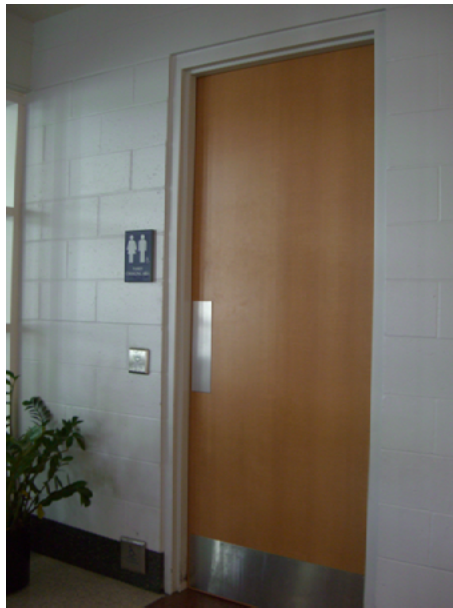
Figure 1: Family/Unisex Locker Room located on the main level of the facility off the lobby.

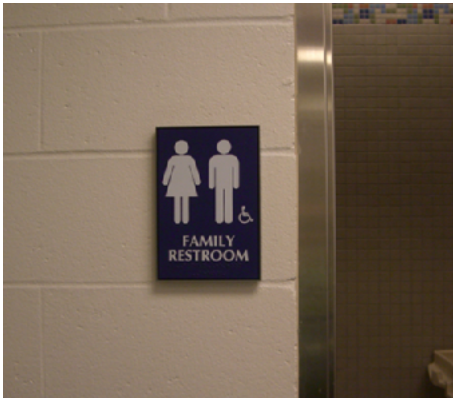
Figure 2: Family Restroom located off main room in the Family/Unisex Locker Room

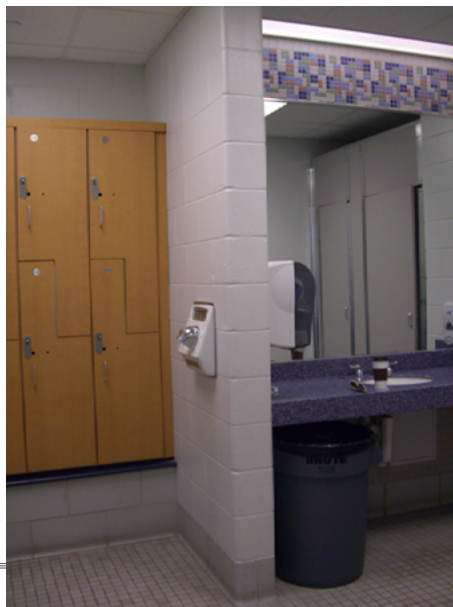
Figure 3: Main room of the Family/Unisex Locker Room.

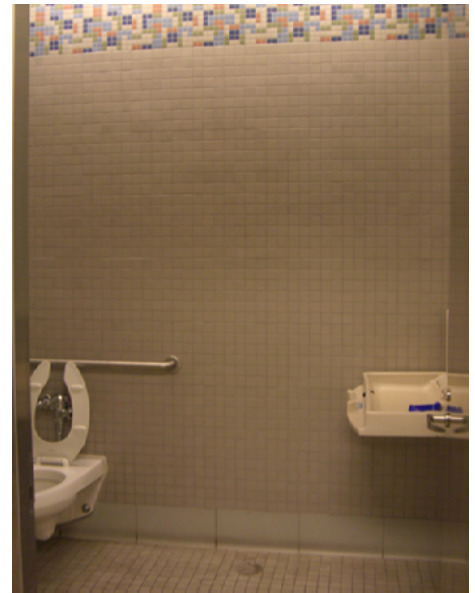
Figure 4: Family Restroom is outfitted with a toilet, a sink, a paper towel dispenser, and a changing station.

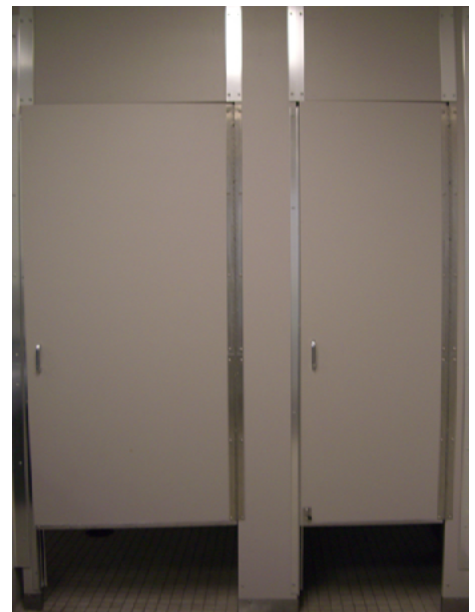
Figure 5: Large shower stalls with good enclosure.

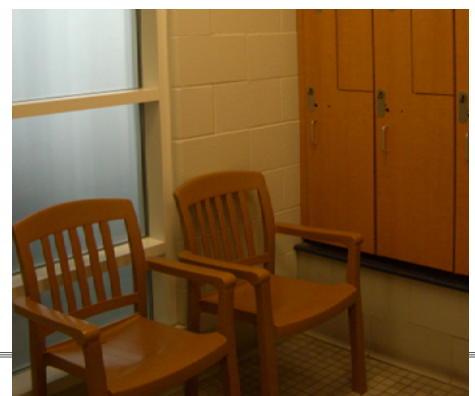
Figure 6: Chairs located in Locker Room - no lactation space provided.

- Consists of a main room (Fig. 3) with a separate unisex universally designed bathroom and 2 shower stalls off of main room.
- Lactation Space (Bad)
  - No designated space for lactation other than the separate family restroom which does not include a chair. (Fig. 4) No pumps supplied. Woman could lock door to family restroom but she would still be using the toilet as her seat. The separate family restroom is safe and clean but it is not a convenient space for a woman to nurse or pump.
- Shower Partitions (Better)
  - Stall partitions for showers do not provide the same degree of privacy that the private shower rooms in the ARC facility afford patrons however they do provide ample space and are the proper height (4" to 6") from the floor for privacy. (Fig. 5)
- two chairs in the main room (Fig. 6)
- has direct access to the indoor pool

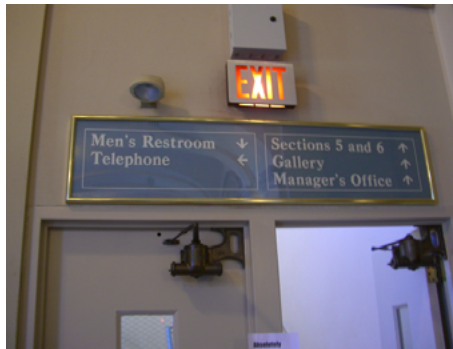
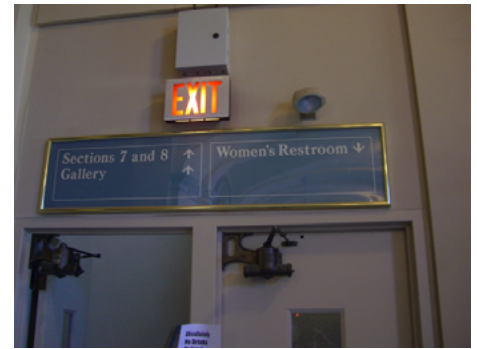
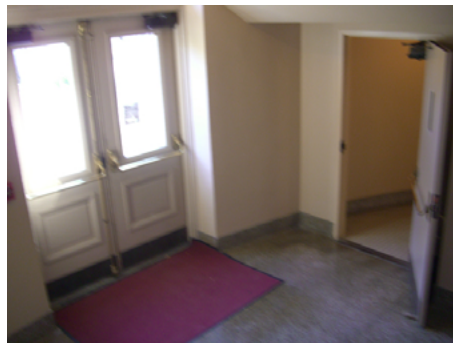
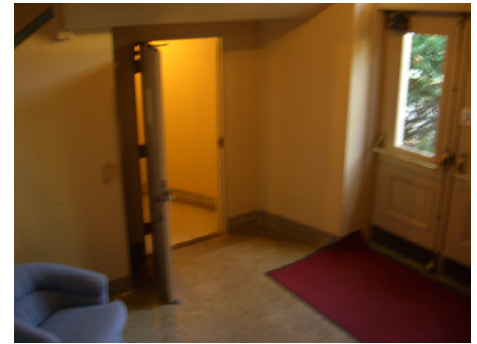
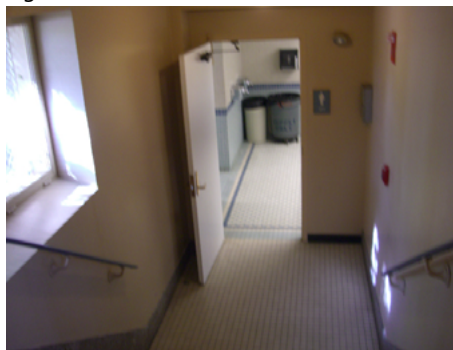
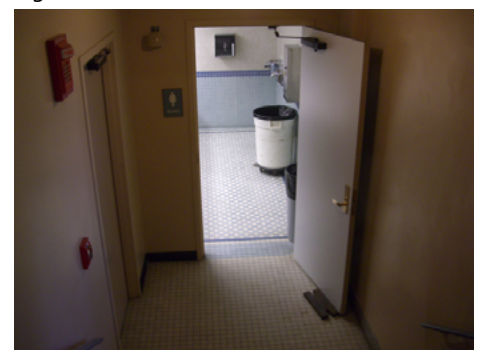
- No Family Restrooms
- No Unisex Restroom
- One Men's Restroom located at east end of building down a flight of stairs from the ground level and two flights of stairs from the entrance level of the building.
- One Women's Restroom located at west end of building (same level situation as men's room)
- + Adequate privacy separation between hallway and interior of the bathrooms - no "line of sight" issue
- Seems to be an issue with accessibility in these bathrooms- if there is a unisex or universal design bathroom one would have to be specially directed toward it because no signage exists.

Figure 1-6: Progression from lobby of the Auditorium to the men's and women's restrooms. Patrons must descend a flight of stairs to a ground level entrance to building and continue down a second set of stairs before reaching bathrooms.

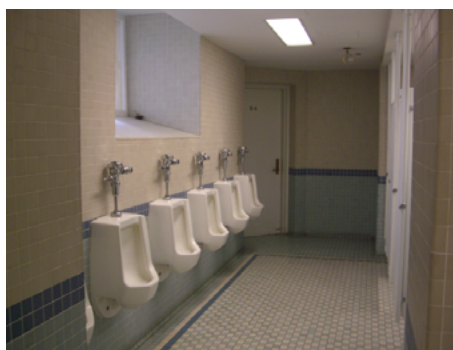
Figure 7: Men's Restroom - No partitions between urinals.

- Partitions (Bad) (Fig. 7)  
No partitions between urinals
- Changing Station (Bad)  
No changing station provided.

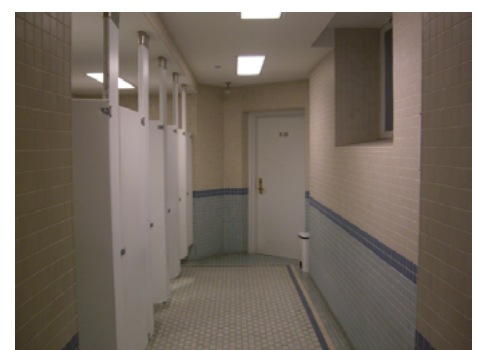
Figure 8: Women's Restroom partitions are too close together and the distance from the ground is too high.

- Lactation Space (Bad)  
Lactation space is non-existent and thus does not meet the legal requirements for reasonable accommodations for nursing mothers.
- Partitions (Bad) (Fig. 8)  
Toilet partition distance from the ground is too high allowing people to see under the stall. Feet and shoes can be identified.
- Changing Station (Bad)  
No changing station provided.

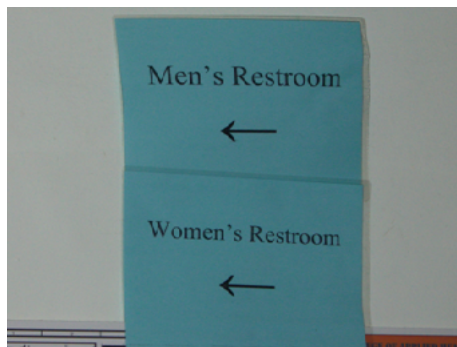
Figure 1: Temporary directional signage due to construction.

- No Family Restrooms
- Unisex Restroom located in the southeast corner on the 3rd floor of the building. One would have to know this exists in order to find it - lack of permanent signage indicating bathrooms existence or location
  - One Men's Restroom and one Women's Restroom located on each floor.
  - One Women's Restroom located on second floor of building
  - Building is currently under construction-it is possible that there would be bathrooms in the addition.
- Bathroom directional signage not permanent (Fig. 1)
- + Good privacy separation between hallway and interior of the bathrooms
- + no "line of sight" issues (Fig. 2)

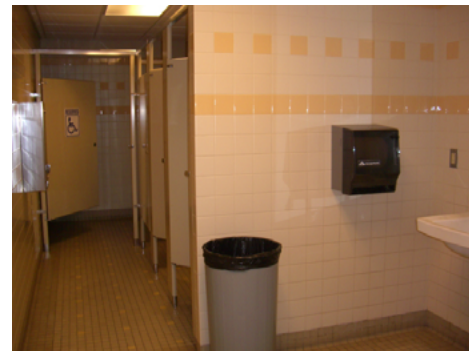
Figure 4: First floor women's restroom

- Lactation Space (Bad)
  - Lactation space is non-existent and thus does not meet legal requirements for reasonable accommodations for nursing mothers.
- Partitions (Bad)
  - Toilet partition distance from the ground is too high allowing people to see under the stall. Feet and shoes can be identified. (Figure 4)
- Changing Station (Bad)
  - No changing station provided.

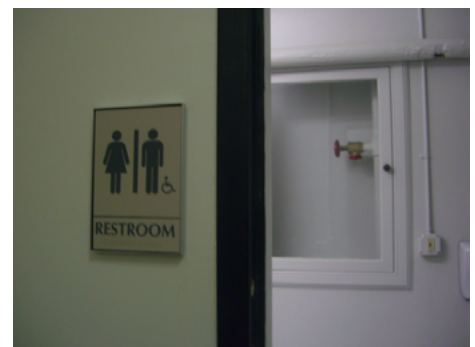
Figure 5: Unisex bathroom signage

+/- The Unisex restroom is large and can be locked. (Fig. 5) It is outfitted with a urinal and a toilet (Fig. 6) but there is not much room for adding any sort of accommodations for nursing mothers. It does not have potential to be the Best Family Restroom but it does have space to accommodate adding a changing station.

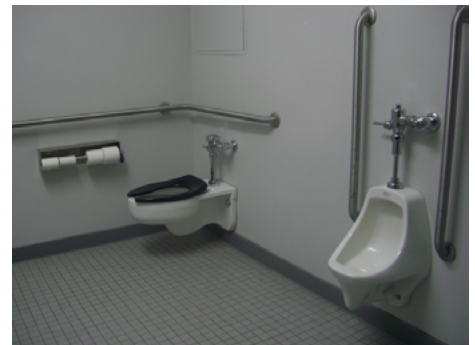
Figure 6: Interior of unisex bathroom

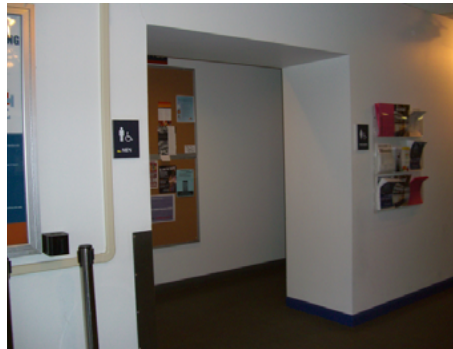
Figure 1: Bathrooms are easy to find located directly off the lobby.

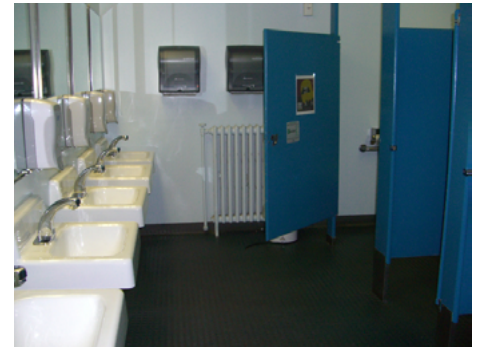
Figure 4: women's restroom

- Lactation Space (Bad)
  - Lactation space is non-existent and thus does not meet legal requirements for reasonable accommodations for nursing mothers.
- Partitions (Bad)
  - Toilet partition distance from the ground is too high allowing people to see under the stall. Feet and shoes can be identified. (Figure 4)
- Changing Station (Bad)
  - Located inside the universal design stall changing station is not located near a sink or paper towels (Figure 4)

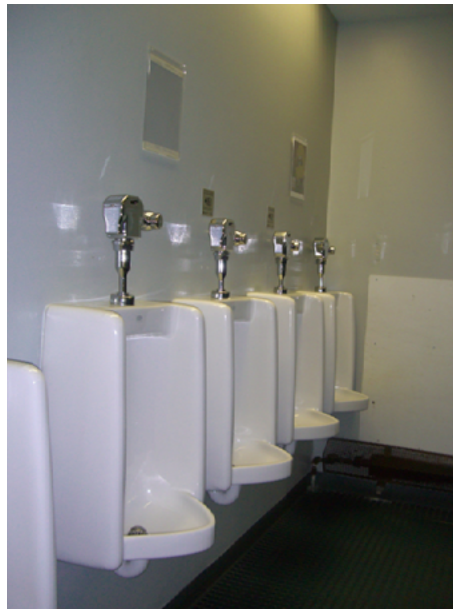
Figure 2: Urinals in men's restroom

- Partitions (Bad)
  - No Partitions between men's urinals (Figure 2)
- Changing Station (Better)
  - Baby-changing station is located near a sink and paper towels. (Figure 3)

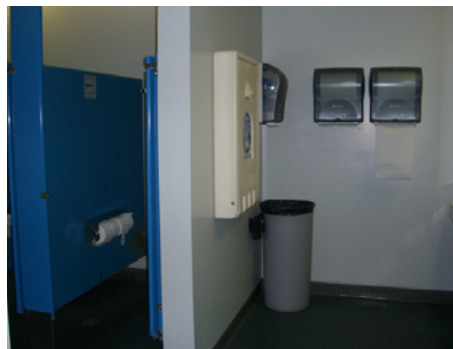
Figure 3: Baby-changing station in men's restroom

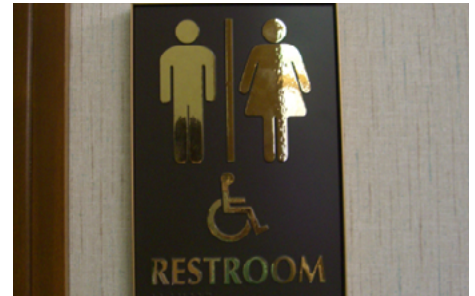
Figure 1: Unisex restroom signage

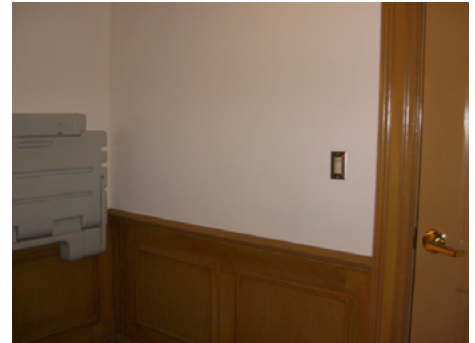
- Partitions (Bad)
  - No Partitions between men's urinals
- Changing Station (Bad)
  - Located in the vestibule between the bathroom and the hallway - it would be inconvenient to use a changing station that is located in flow of traffic the changing station is not located near a sink or paper towels. (Fig. 2)

Figure 2: Baby-changing station in first floor women's restroom.

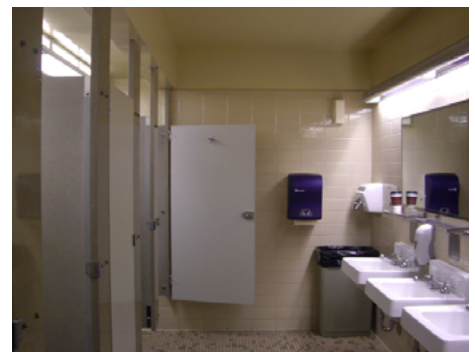
Figure 3: Main floor women's restroom.

- Lactation Space (Bad)
  - Lactation space is non-existent and thus does not meet the legal requirements for reasonable accommodations for nursing mothers.
- Partitions (Bad)
  - Toilet partition distance from the ground is too high allowing people to see under the stall. Feet and shoes can be identified. (Figure 3)

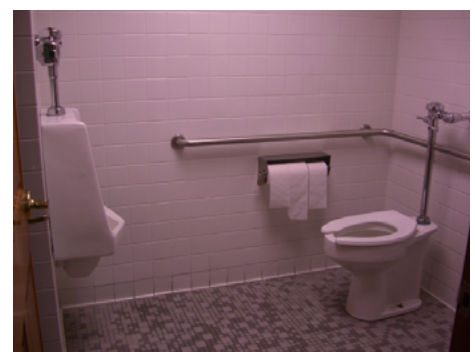
Figure 4: Unisex restroom outfitted with toilet and urinal - no changing station.

- +/- Would require renovation in order to serve as a Family Restroom. Combining the two Unisex Restrooms into one Family Restroom might be a viable option in order to fit all amenities of a family restroom into the space. (Fig. 4)

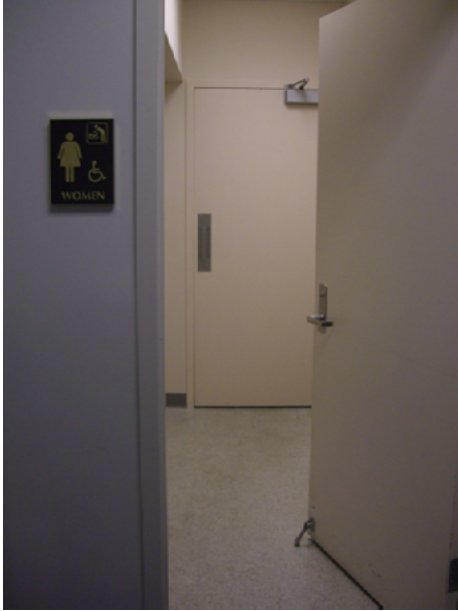
Figure 5: Vestibule between hallway and interior of the restroom in basement women's restroom

- + Excellent privacy separation between hallway and interior of bathrooms on Basement Level
- + Vestibule separates door from hallway and door into interior of the bathroom. (Fig. 5)

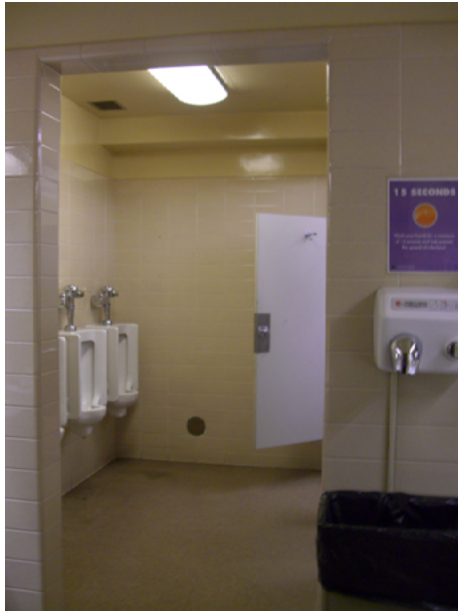
Figure 6: Urinals in basement men's restroom

- Partitions (Bad)
    - No partitions between men's urinals (Fig. 6)
  - Changing Station (Better)
    - Baby-changing station is located near a sink and paper towels.
- ### Women's Restroom
- Lactation Space (Bad)
    - Lactation space is non-existent and thus does not meet the legal requirements for reasonable accommodations for nursing mothers.

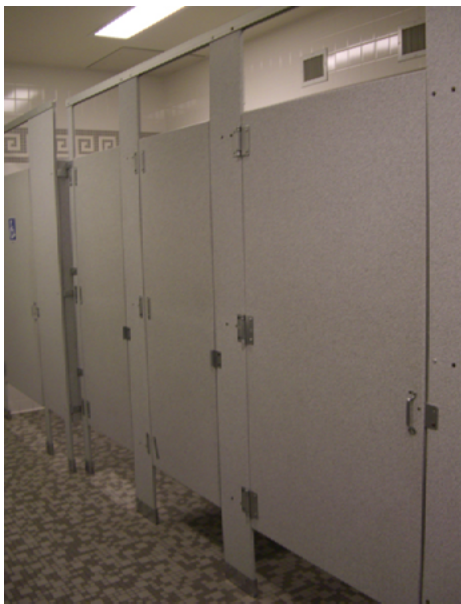
Figure 7: Stalls in basement women's restroom

- Partitions (Better)
  - Partitions provide adequate spacing between toilet stalls and proper height (Between 4" to 6" from ground) for privacy (Figure 7)
- Changing Station (Better)
  - Baby-changing station is located near a sink and paper towels. (Figure 8)

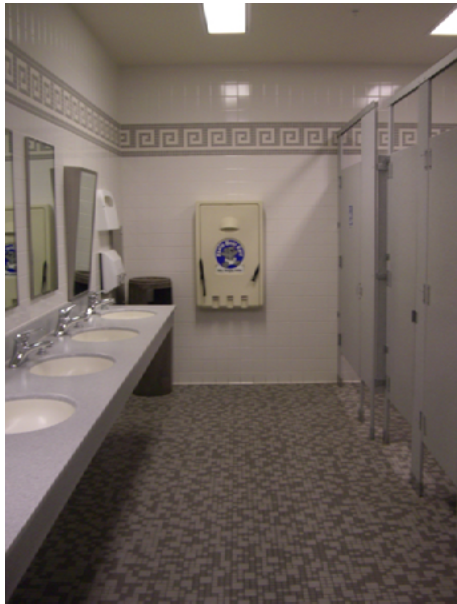
Figure 8: Baby-changing station in basement women's restroom

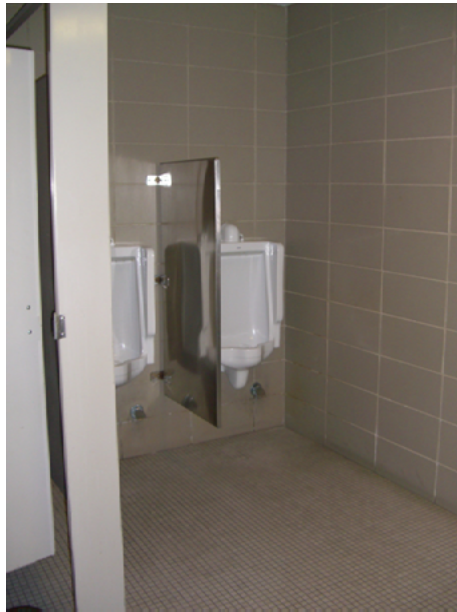
Figure 1: Urinals in men's restroom

- Partitions (Better)  
Partitions are present and deep (extends 2'-6" from wall and goes down to about 10" from the floor) Spacing between partitions seems to be a little cramped. (Fig. 1)
- Changing Station (Better)  
Baby-changing station is located near a sink and paper towels. (Fig. 2)

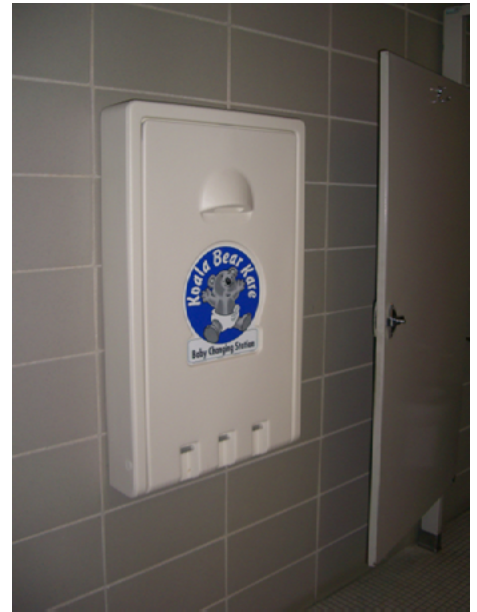
Figure 2: Baby-changing station provided in men's restroom.

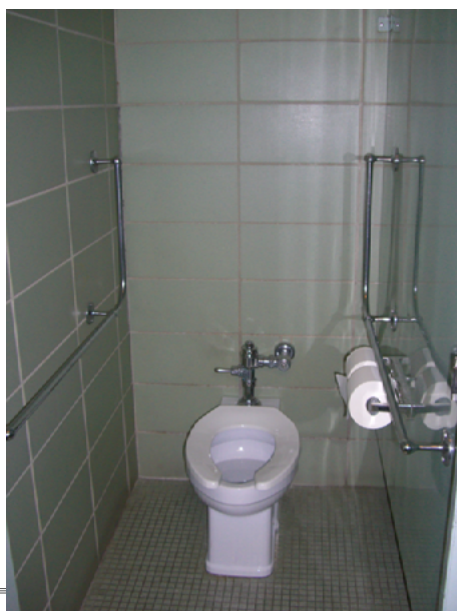
Figure 5: Cramped stall space in women's universal design stall.

- Lactation Space (Bad)  
Lactation space is non-existent and thus does not meet the legal requirements for reasonable accommodations for nursing mothers. There is a bench provided in the bathroom but it is old, dirty, and is visible from the hallway if the door to the bathroom is open. (Fig. 3 & 4)
- Partitions (Bad)  
Toilet partition distance from the ground is too high allowing people to see under the stall. Feet and shoes can be identified. Also partition spacing is cramped. (Fig. 5)
- Changing Station (Bad)  
No changing station provided. (Fig. 6)

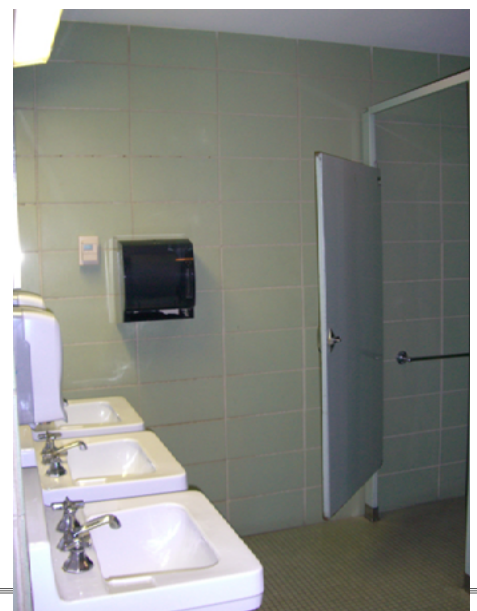
Figure 6: No baby-changing station located in women's restroom

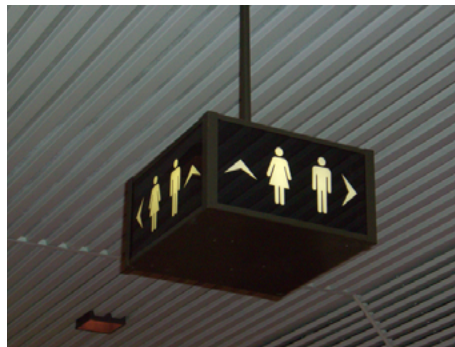
Figure 1: Signage for the men's and women's restrooms on the main lobby level.

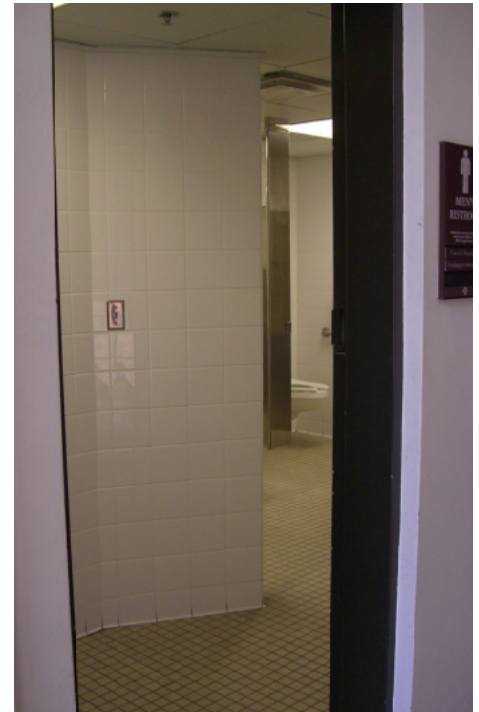
Figure 2: Line of site issue from the hallway into the universal design stall in the men's restroom on the main lobby level.

- No Family Restrooms
- Unisex universal design restrooms located on the upper parking level off the parking level lobbies.
- One Men's Room and One Women's Room located on Main Lobby Level.
- One Men's Room and One Women's Room located off of each Lower Level Theater Lobby. (Fig. 1)
  - There is a line of site issue from the hallway into the universonally designed stall in the Men's Restroom on the Main Lobby Level. (Fig. 2)

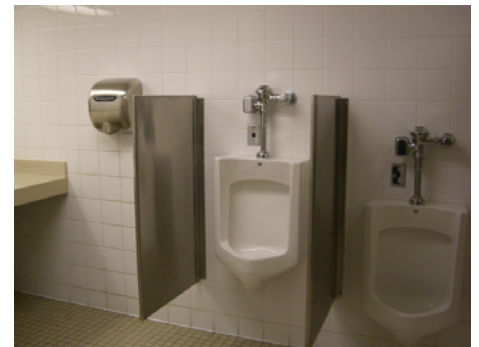
Figure 3: Urinal partitions in men's restroom on main lobby level

- Partitions (Better)
  - Partitions are present and deep (extends 2'-6" from wall and goes down to about 10" from the floor) (Figure 3)
- Changing Station (Bad)
  - No Changing Station provided.

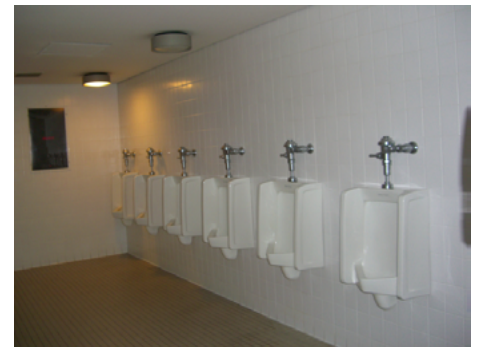
Figure 4: Urinals in men's restrooms on the theatre lobby level

- Partitions (Bad) (Fig. 4)
  - No Partitions between men's urinals.
- Changing Station (Bad)
  - No changing station provided.

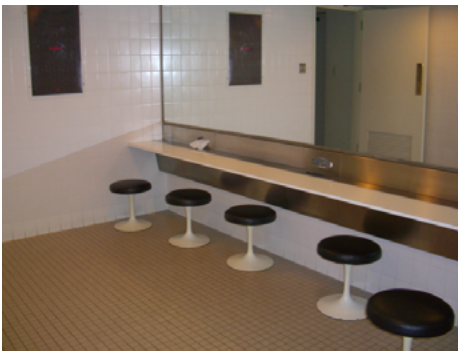
Figure 5: Make-up application areas in women's restrooms on the theatre lobby level

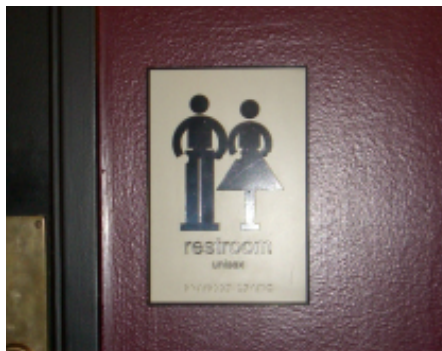
Figure 6: Signage for Unisex Restrooms on the parking lobby level.

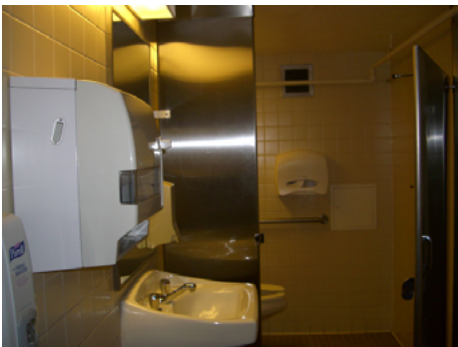
- +/- The Unisex restrooms are small but already equipped with changing stations located near a sink and paper towels. They can be locked and have enough room to be outfitted with chairs and pumps to accommodate a nursing mother. They do not have the potential to be the "Best" Family Restrooms but they do have the potential to be "Better."

Figure 7: 1 of 4 unisex restrooms located off lobby on the upper parking level. 2 of 4 are universally designed.

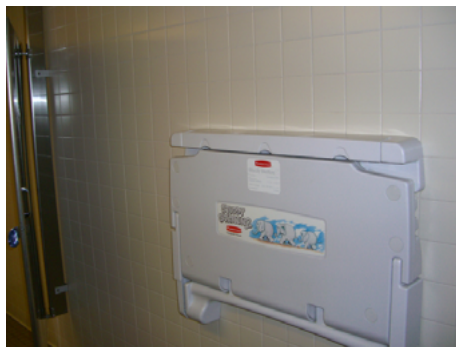
Figure 8: 2 of 4 of unisex restrooms are outfitted with baby changing stations.

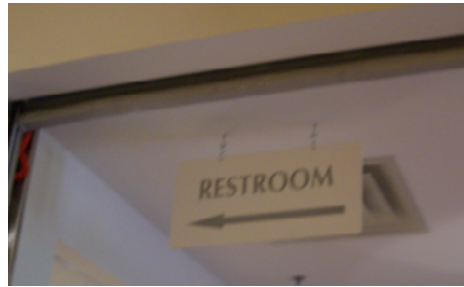
Figure 1: Directional Signage

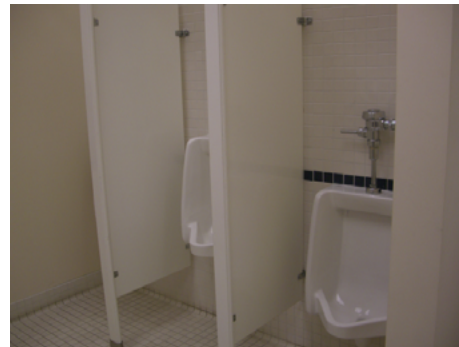
Figure 2: Men's restroom partitions are present, deep, and have adequate spacing.

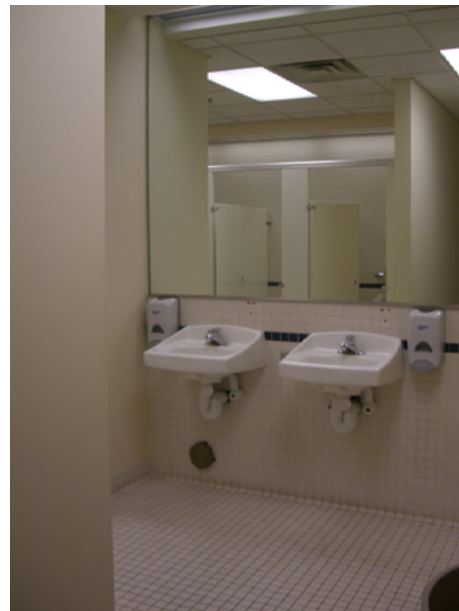
Figure 3: Sinks in the men's restroom. There is enough space on the wall left of the sinks to provide a baby changing station.

- + Partitions (Best)
  - Partitions are present and deep (extends 2'-6" from wall and goes down to about 10" from the floor) Spacing between urinals and stalls allow for larger men and/or men with bulky outerwear to be accommodated and offer more privacy. (Fig. 2)
- Changing Station (Bad) (Fig. 3)
  - No changing station provided.

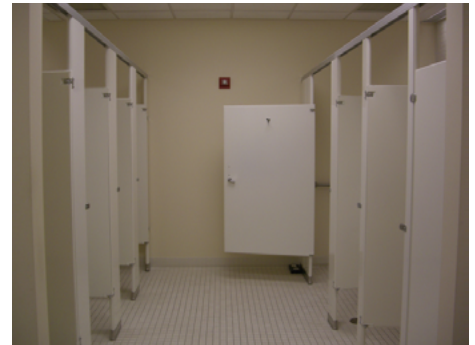
- Lactation Space (Bad)
  - Lactation space is non-existent and thus does not meet the legal requirements for reasonable accommodations for nursing mothers.
- Partitions (Bad)
  - Toilet partition distance from the ground is too high, according to the GEC checklist, allowing people to see under the stall. Feet and shoes can be identified. (Fig. 4)
- Changing Station (Better)
  - Baby-changing station is located near a sink and paper towels. (Fig. 5 & 6)

Figure 4: Women's restroom partition distance from the ground is too high. There is an adequate number of partitions for the size and function of the facility and they are well spaced.

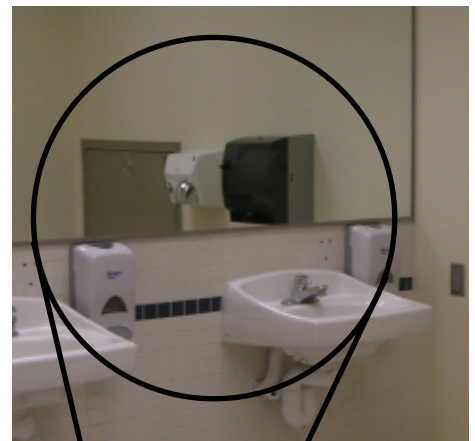
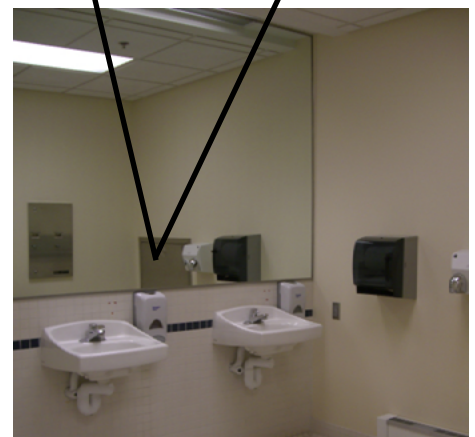
Figure 5 & 6: Changing station in women's restroom is located near the sinks and a paper towel dispenser.
