GEC Space Place Subcommittee
Public Spaces Family Restroom Study
University of Illinois Urbana-Champaign

The Ice Arena
406 E Armory Ave
Champaign, IL

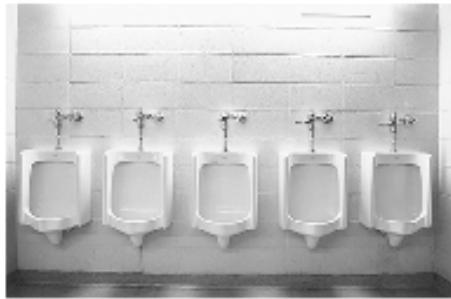
BAD

- No partitions between men's urinals can be uncomfortable for some men.
- Adequate space should be provided between urinals. Most men despise trough urinals.
- Partitions are present, but not enough spacing in between urinal stalls.
- Men with shy bladder syndrome and pauresis suffer when stalls are too close together.
- + Maximum spacing between urinals and stalls allow for larger men and/or men with bulky outerwear to be accomodated and offer more privacy.

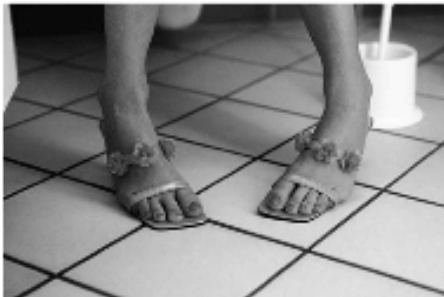
BAD

- Toilet partition distance from ground is too high allowing people to see under stall. Feet and shoes can be identified.
- Women with shy bladder syndrome and pauresis are uncomfortable under these conditions.

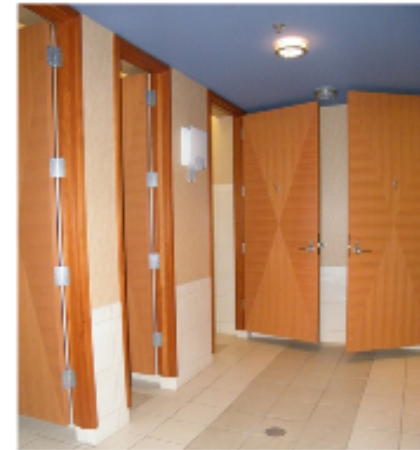
BEST

- + Total enclosure of stalls with door locks provides maximum visual and auditory privacy.
- + Distance between toilet partitions is wide enough to accommodate larger women and bulky outerwear.

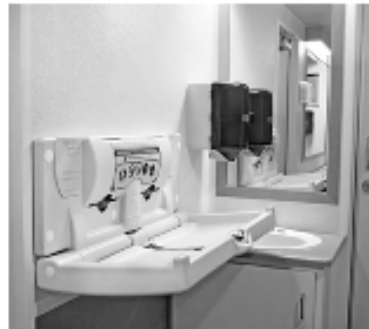
BETTER

- Are there baby-changing stations provided in men's and women's restrooms?
- Is baby-changing station located near a sink and/or paper towels?

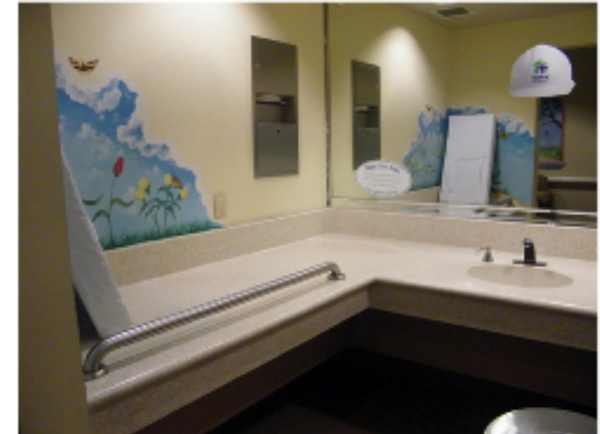
BEST

- + The optimal baby-changing space should provide enough space for baby changing bags and accessories.
- + The location of baby-changing stations should also be convenient for parents with multiple children.

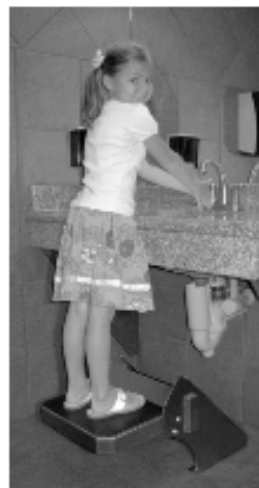
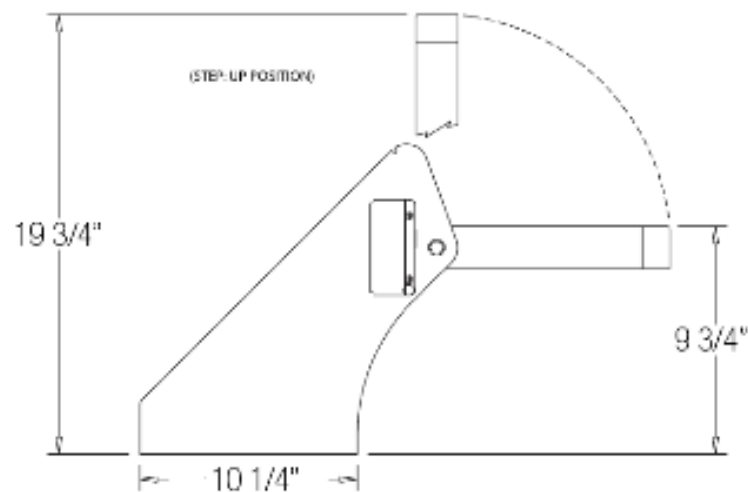
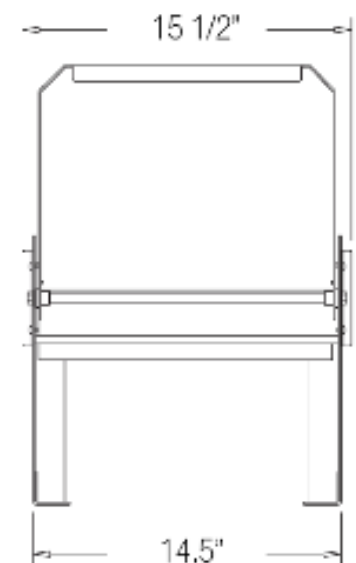
Solution Detail - Step 'N Wash

STEP 'N WASH STEP

SECTION THROUGH STEP

FRONT VIEW IN UP POSITION

- Older or weaker persons may have difficulty lifting children to reach sinks.
- A possible solution is Step 'N Wash, a self retracting step for public restrooms enabling children to safely and effectively wash their hands without assistance. (See next page detail)

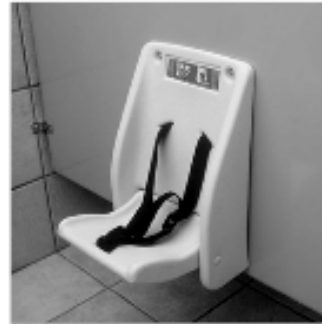
BETTER

- Men or women with several children and/or baggage can have difficulty finding a place for all their items.
- Retractable child protection seat requires minimal space and can be attached to existing stalls.

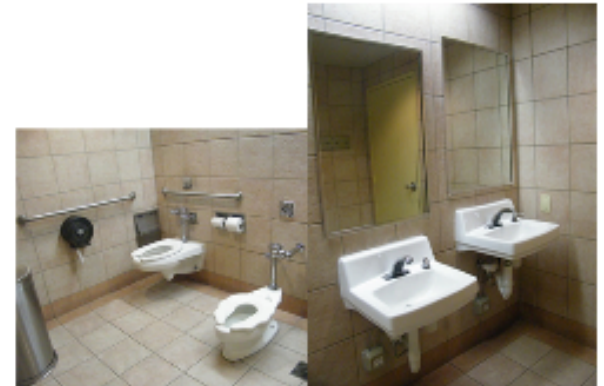
BEST

- + Offer both adult and child sized fixtures in a space approx. 8'-0" X 8'-0".

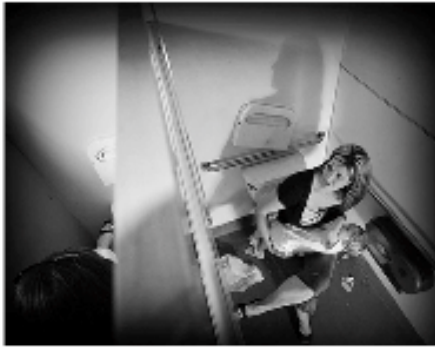
BAD

- Does the lactation space meet the legal requirements - other than a toilet stall -- for "reasonable accommodations" for nursing mothers?
- Is the lactation space in a safe, convenient, clean location?

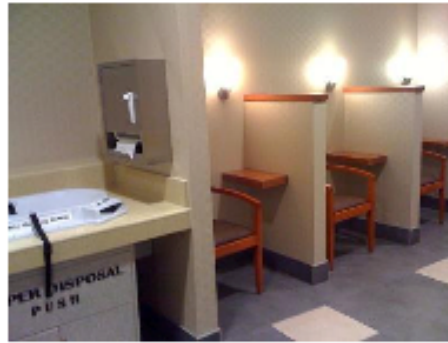
BETTER

- Are pumps supplied that several mothers can share a room different times of the day?
- If no lock is available, are there adequate options for privacy such as drawing down blinds?
- Is the lactation space of high enough quality to allow the building to use the designation "infant friendly" or be part of a Working Well Mom's program?

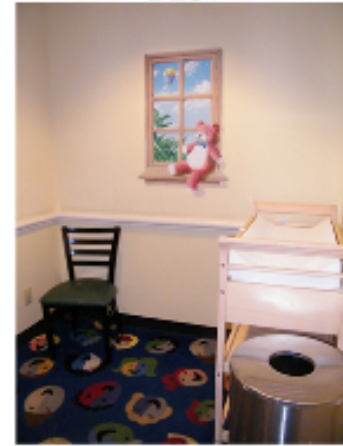
BEST

The best lactation room should include:

- + a sitting area
- + a door with private lock
- + a refrigerator
- + outlets for breast pumps
- + a space approx. 7' x 7'

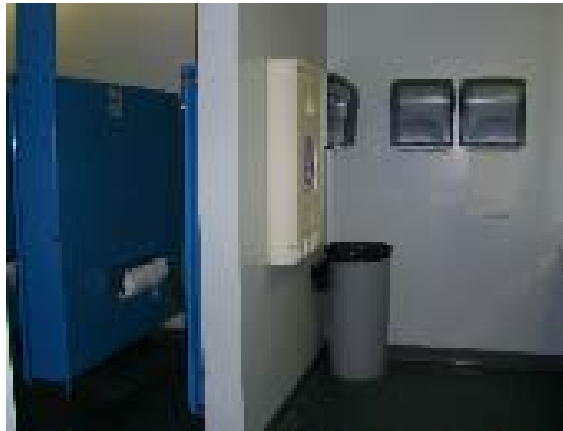
Figure 1

- _Partitions (Bad)
 - No Partitions between men's urinals (Figure 3)
- _Changing Station (Better)
 - Baby-changing station is located near a sink and paper towels. (Figure 1)

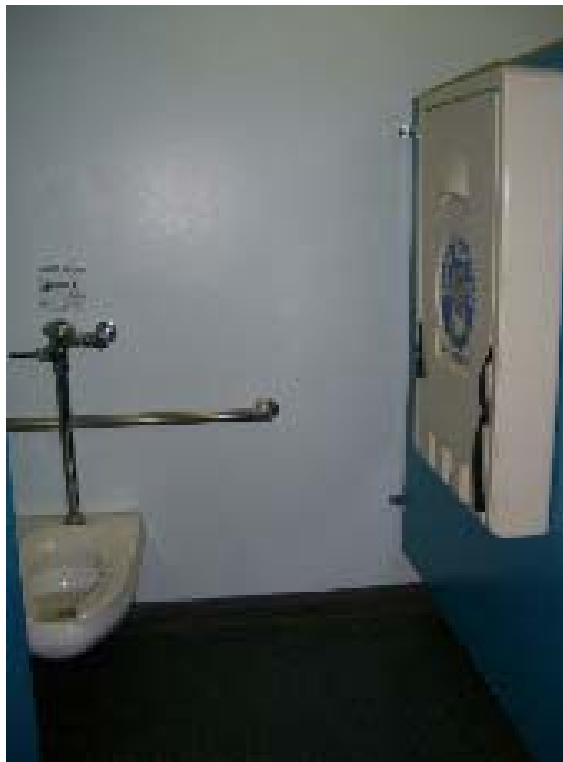
Figure 2

- _Lactation Space (Bad)
 - Lactation space is non-existent and thus does not meet the legal requirements for reasonable accommodations for nursing mothers.
- _Partitions (Bad)
 - Toilet partition distance from the ground is too high allowing people to see under the stall. Feet and shoes can be identified. (Figure 4)
- _Changing Station (Bad)
 - Located inside the handicap stall the changing station is not located near a sink or paper towels (Figure 2)
